**PROPERTY INSPECTION REPORT**

**Bill Kania #HI 11351**  
**GREATER ORLANDO HOME INSPECTIONS**

**Maderia Dr, Kissimmee FL 34758**  
**Inspection Prepared For: Vince**

**Date of Inspection: 12/8/18**  
**Year Built: 1985 Size: 1200 sq ft**  
**Weather: Sunny 85 degrees**

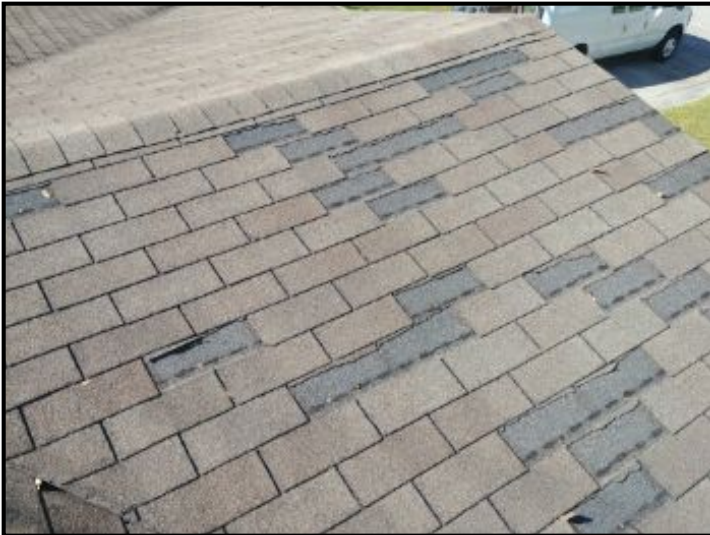
- Recommend roofing contractor to evaluate.
- Some shingles damaged.
- Some shingles &/or tabs missing.
- Exposed nails on roofing material. Recommend sealing all fastener heads.

Broken shingles

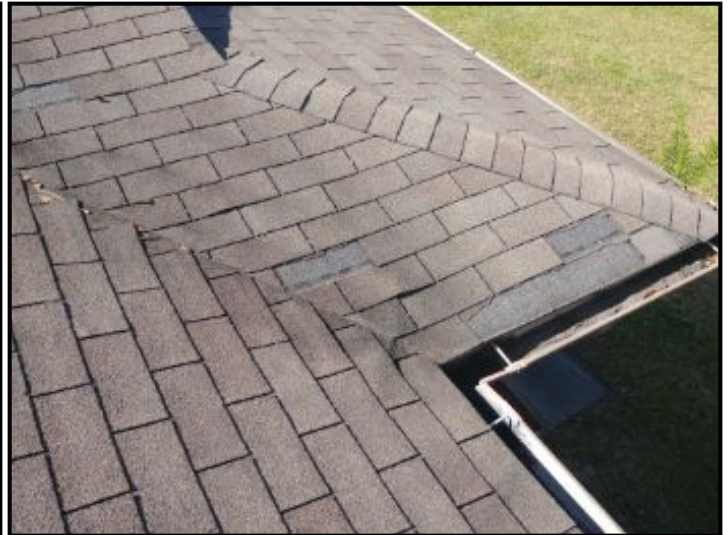
Missing shingles at valley

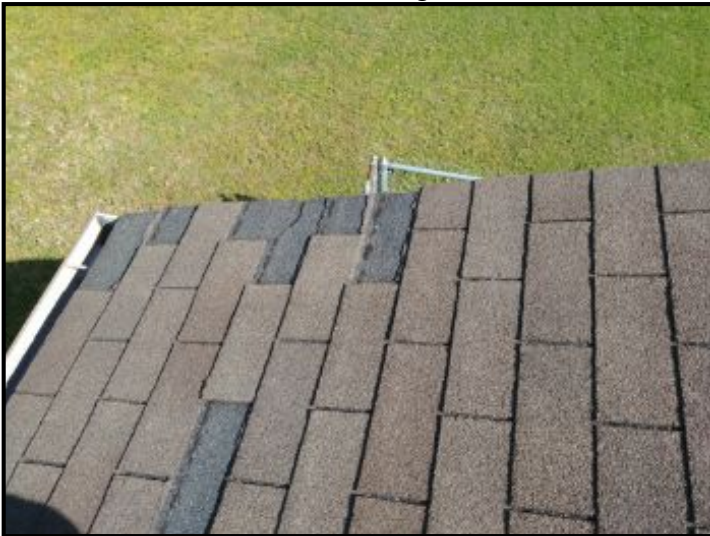
Missing shingles at rake and eaves

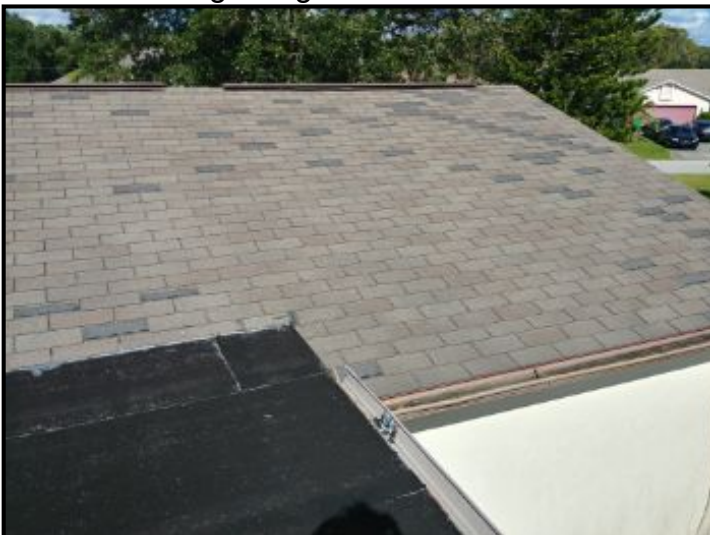
Missing/broken shingles- west

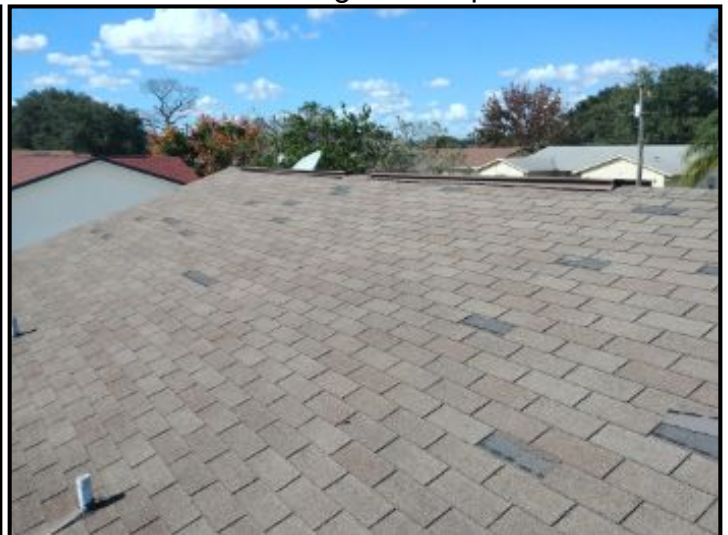
Broken shingles- west

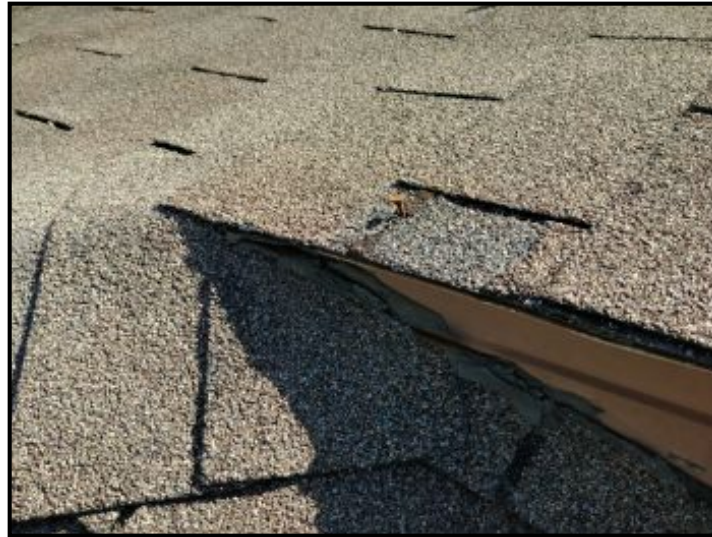
Flashing not visible

- In the inspectors opinion the flashings are near the end of their useful life due to wear.
- Recommend review by a licensed roofer for repair or replacement as necessary.

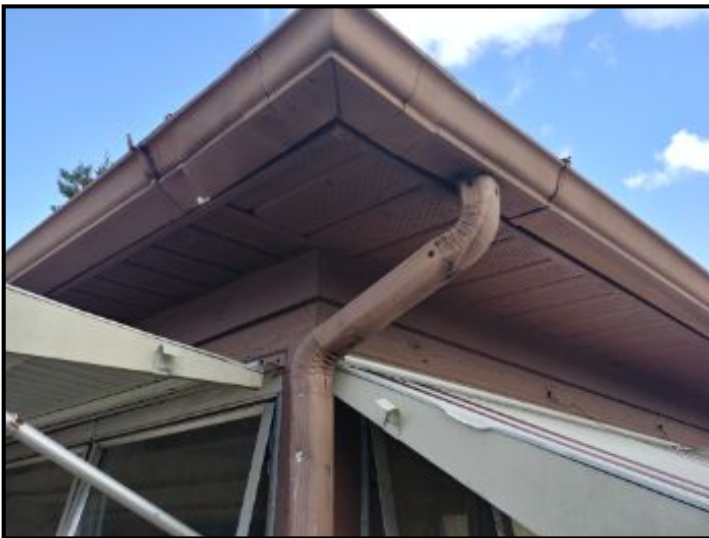
Loose gutter and leader- rear patio

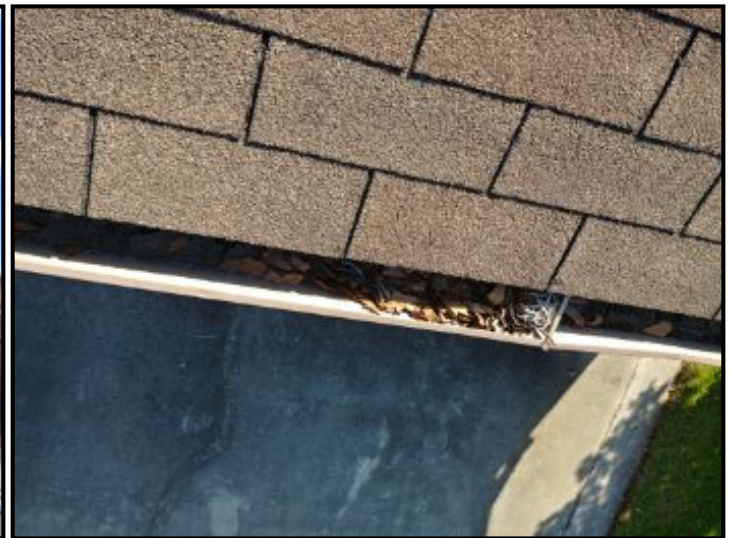
Leaves clogging gutter

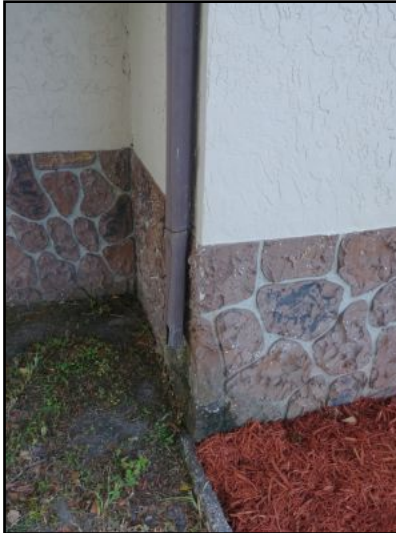
- Extensions / Splash blocks missing or insufficient: Install to divert water away from the foundation.
- Clean gutters: Significant amounts of debris evident.
- Downspouts missing; recommend installation.
- The downspout off of the back porch roof gutter system is discharging against the foundation walls it is not directed far enough away from home; it should be at least 6 feet away.
- Gutter leak(s) noted.

Gutter discharging against foundation and bed

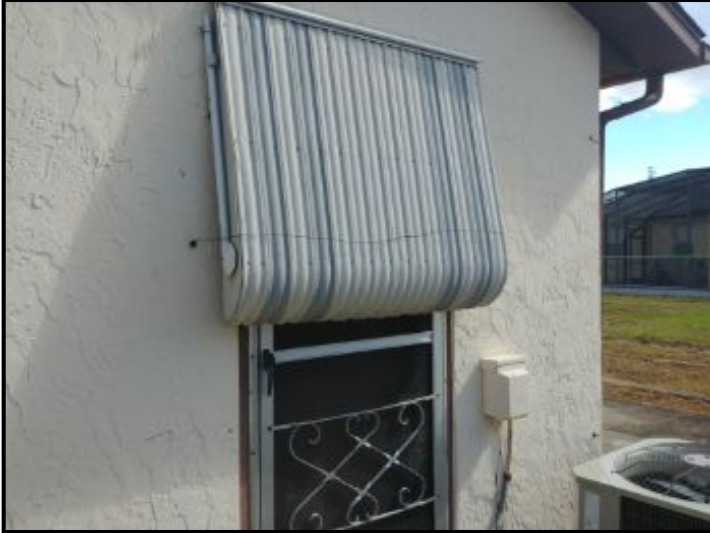
- Sliding doors to backyard.
- Front door and hardware is damaged, hardware should be replaced and a deadbolt installed.
- SECURITY CONCERN: Garage access door is blocked by exterior awning wired in place

Awning blocking exit

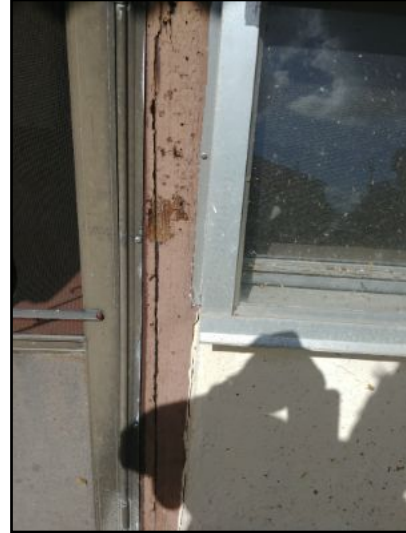
Wood at screen door extreme wear - rear

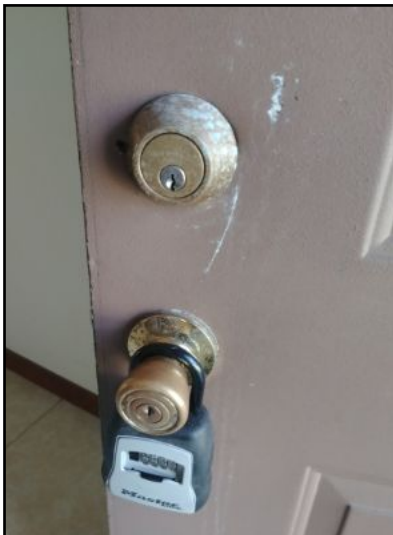
Door hardware damaged

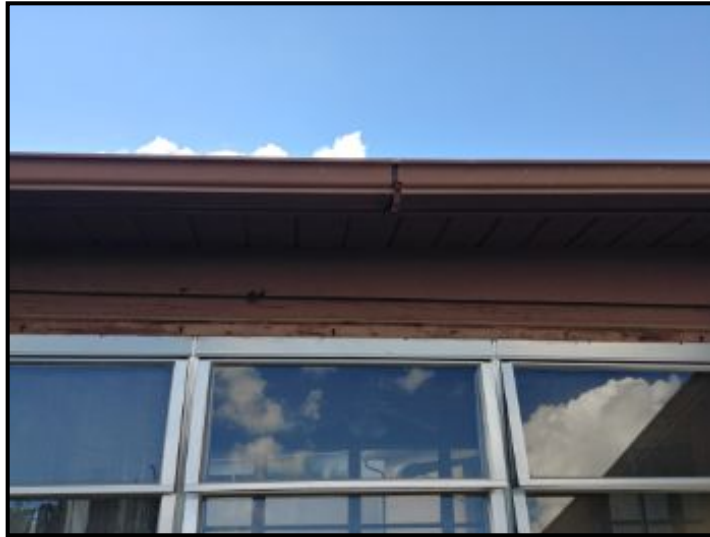
Wood worn and pitted- rear patio

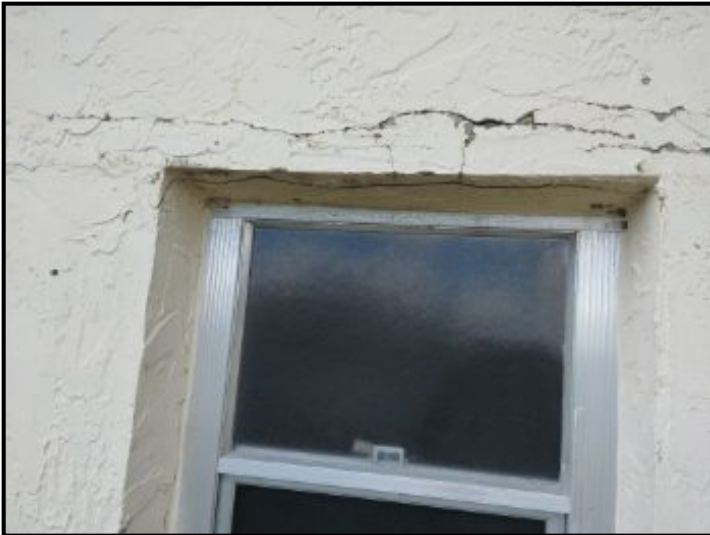
- **The exterior stucco appears to be in a weathered condition. Stucco is a paintable surface, and based on the condition we suggest doing so.**
- **We recommend sealing holes & gaps in the stucco to keep water infiltration from causing further damage.**

Extreme cracks over master bath window- north

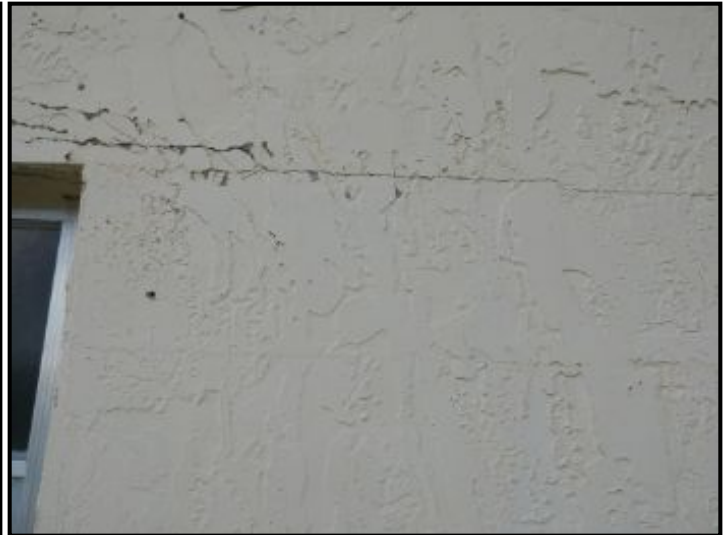
Cracks in stucco- north

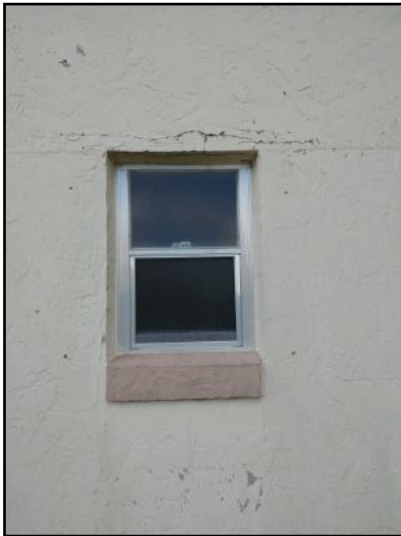
Cracks over window- north

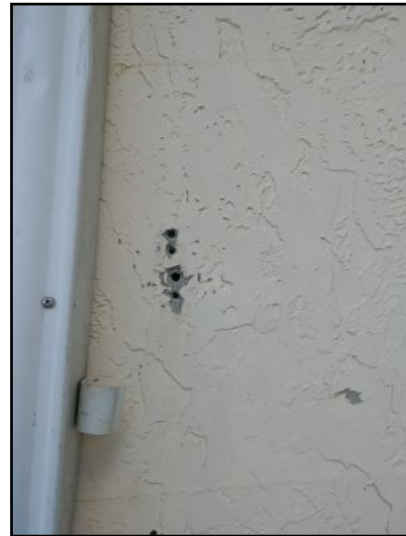
Holes in stucco and block- north

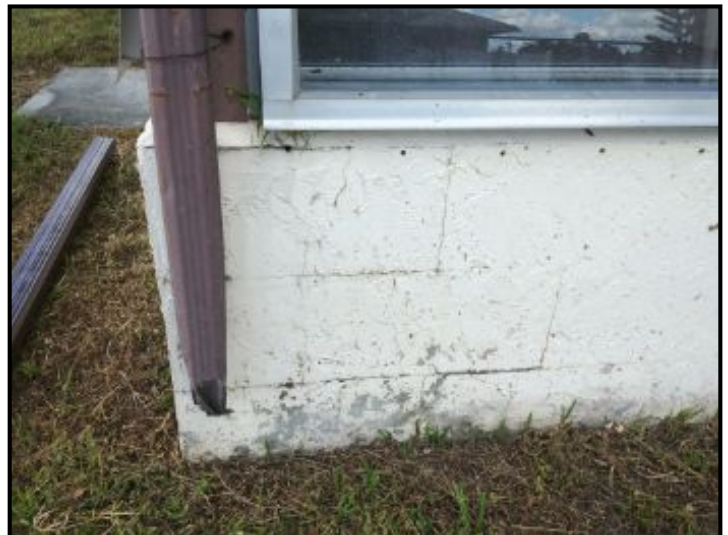
Cracks in block/crushed leader/missing elbow

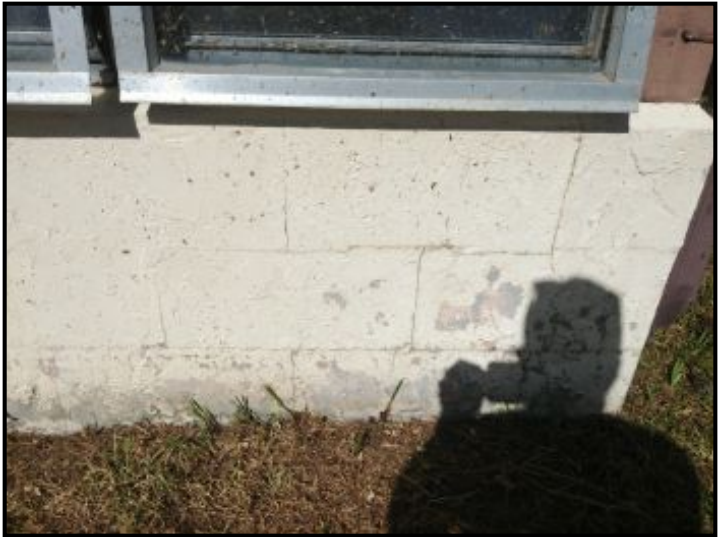
Cracks in block patio outside

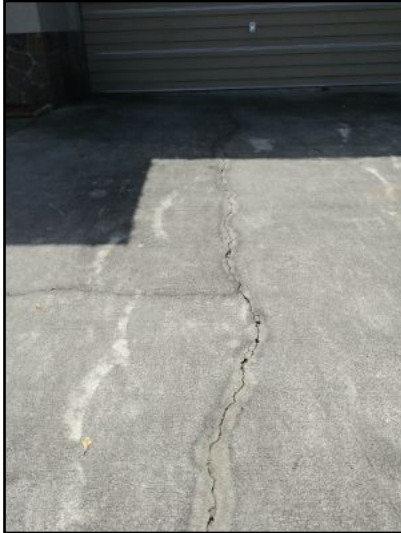
• **Moderate cracks in driveway. Repair and / or monitor for expansion and development of trip hazards.**

Cracks in driveway

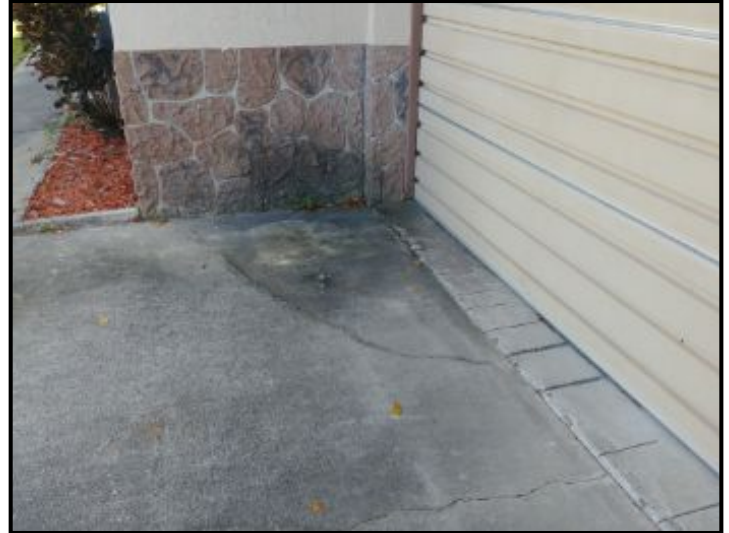
Improper slope due to cracks and back pitch

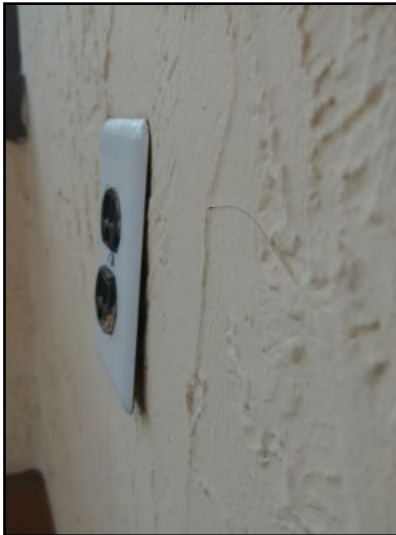
Patio switch plate loose

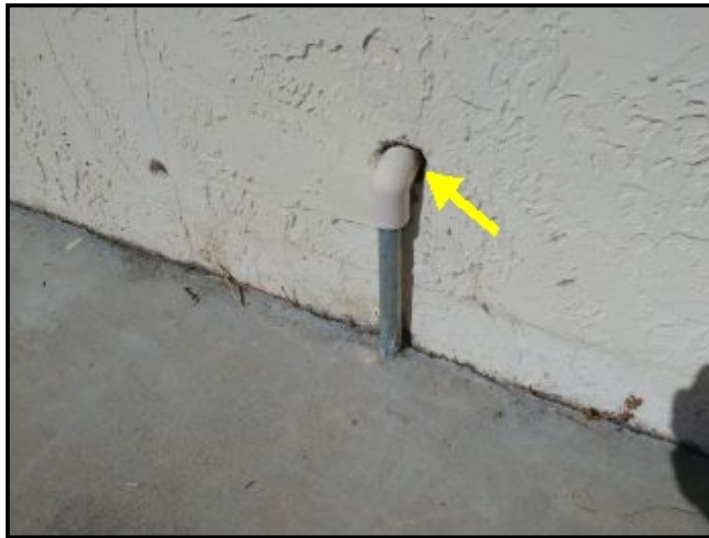
Needs sealing into house

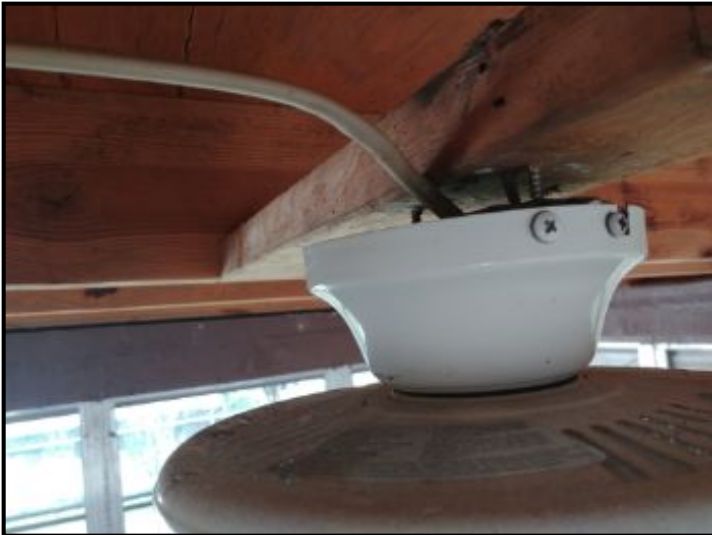
Missing mounting box

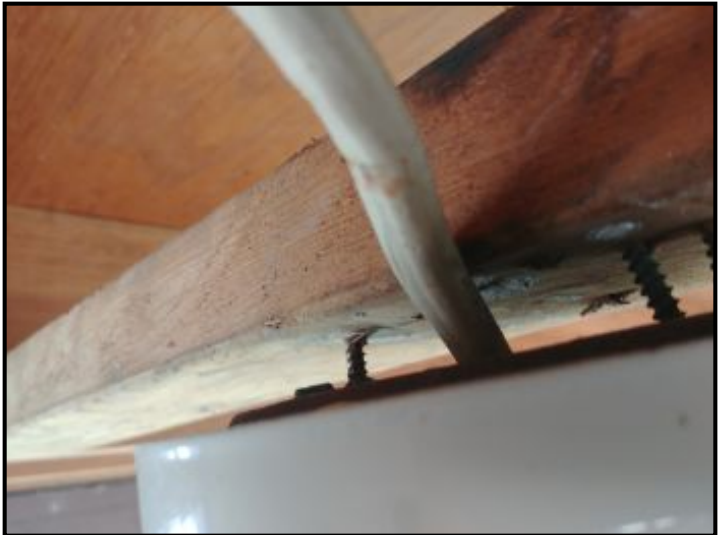
Patio fan improper mounting

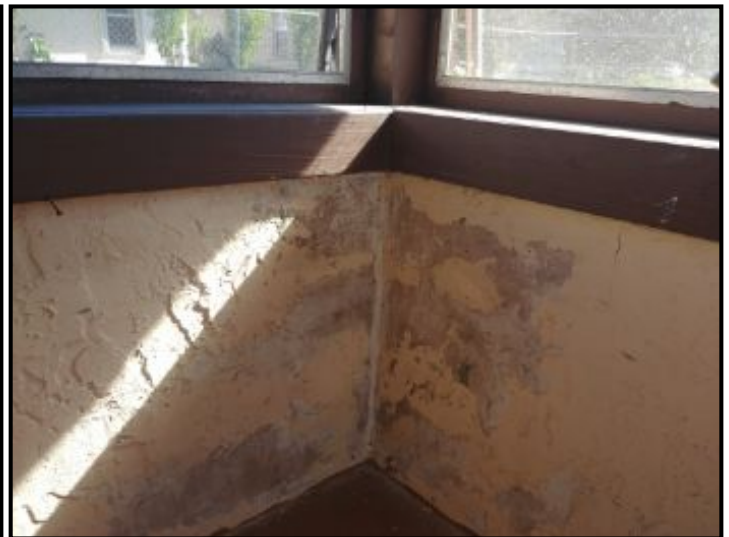
Loose/peeling paint- patio wall

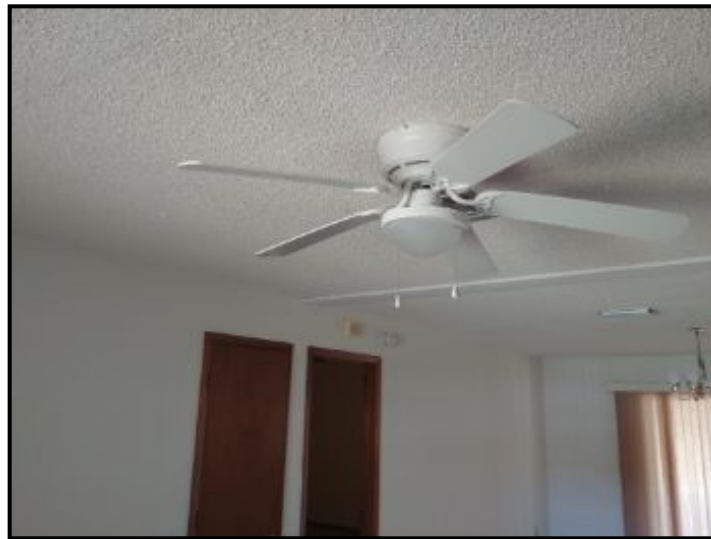
Living Room

- The ceiling fan did not operate when tested.
- The fan blades wobble when tested.
- The ceiling fan appears to be loose at ceiling. This is a safety issue, recommend contacting a licensed electrician to repair.

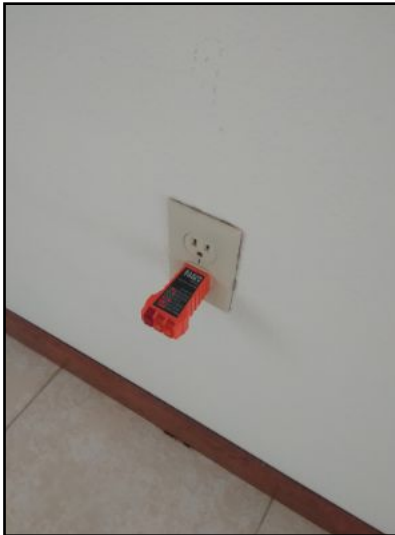
- The majority of grounded receptacles , were tested and found to be wired correctly.
- LR outlet lower not functioning

LR outlet lower not working

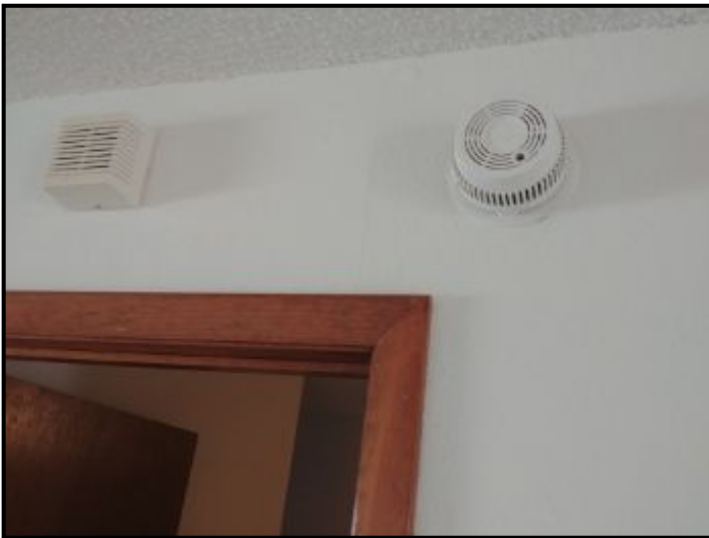
- **SAFETY CONCERN:** The smoke alarm(s) did not operate when tested. You need to be alerted in case of a fire. Recommend repair or replacement of the smoke alarm.
- Old detectors. Smoke detectors last 6-10 years. Recommend replacing.

Living Room smoke detector/alarm box

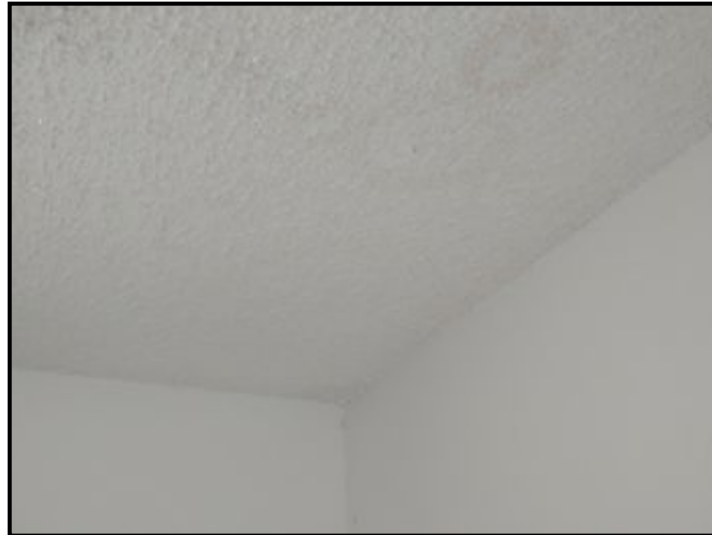
- There are drywall ceilings noted. • The ceilings are popcorn texture
- Minor damage from what appears to be excess moisture.
  - Evidence of past leaking was noted.

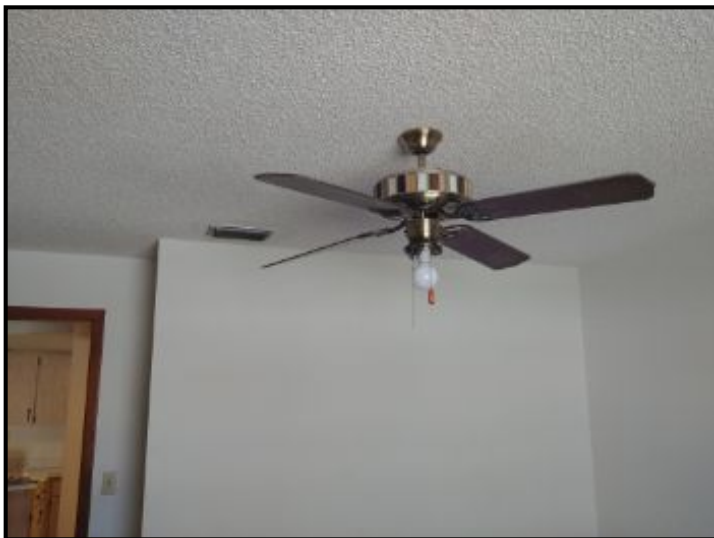
Front south BR

- The ceiling fan is a worn unit that has reached the end of its useful life.
- The ceiling fan did not operate when tested.

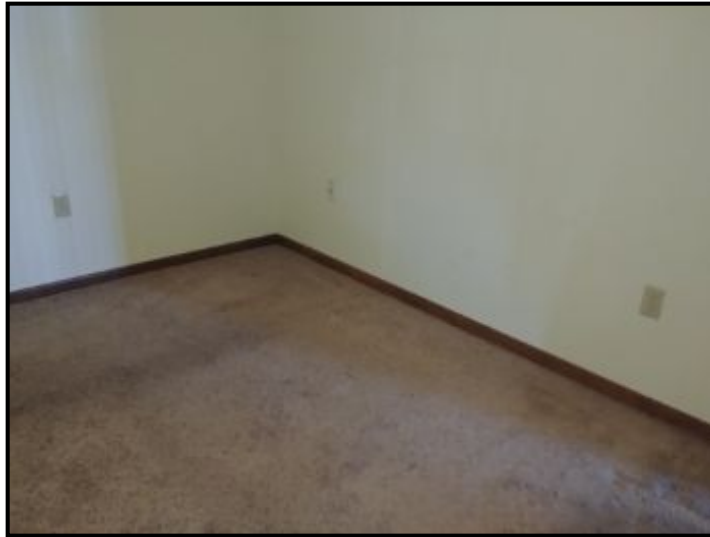
Building codes with which new homes must comply require the installation of AFCI protection of all bedroom outlets. This type of protection is designed to detect electrical arcing, which is a potential fire hazard.

No AFCI breakers in BR

- It is HIGHLY recommended to (have a qualified electrician) install an Arc Fault Circuit Interrupter breaker in place of the one currently protecting the bedroom circuits

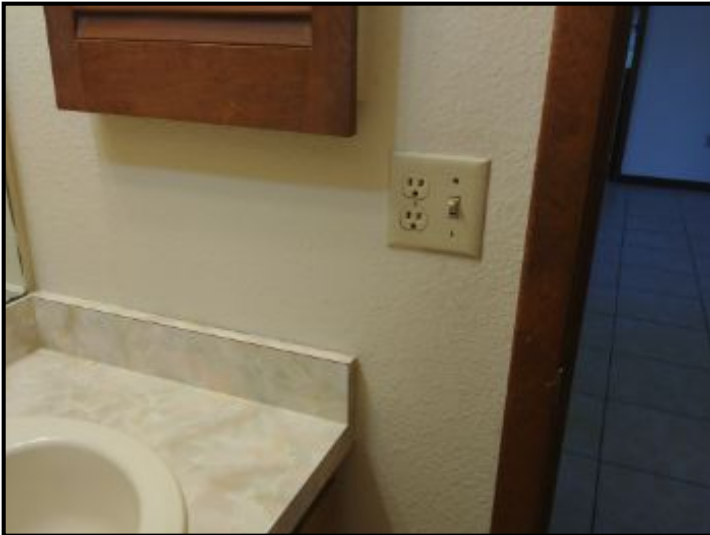
- No GFCI protection present, suggest installing GFCI protected receptacles for safety.
- Electrical outlets in this bathroom appeared to be in serviceable condition at the time of the inspection but had no Ground Fault Circuit Interrupter (GFCI) protection.

NO GFCI in hall bath

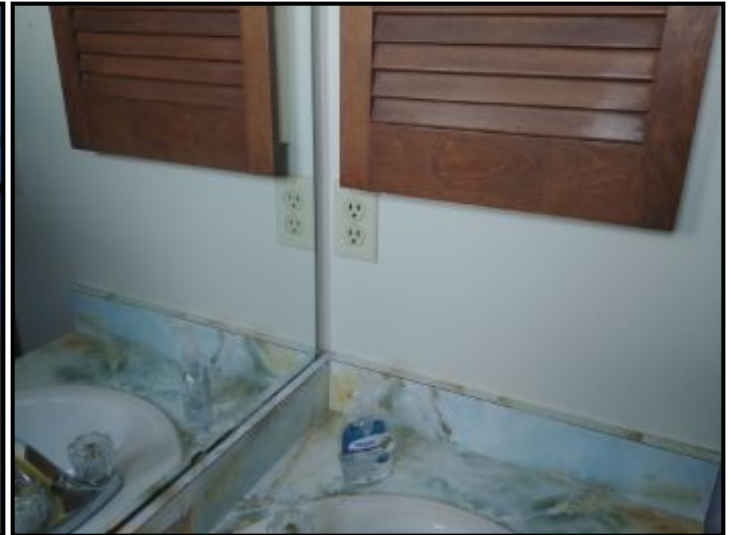
No GFCI in master bath

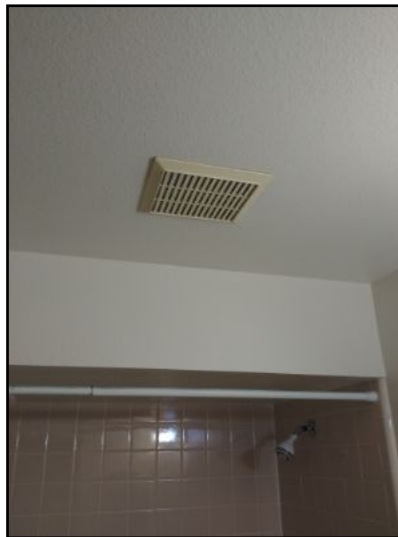
- The bath fan is a worn unit which may be at the end of its useful life.
- Exhaust fan is inoperable.

Not working

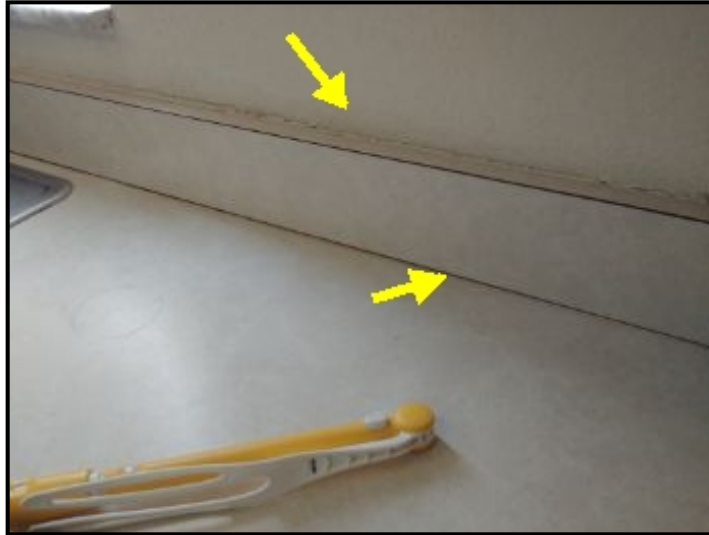
Gaps in back splash and to wall

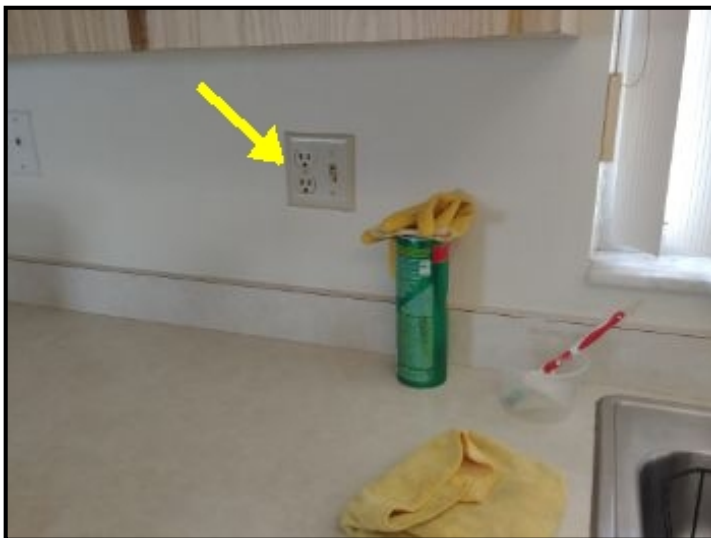
No GFCI in kitchen area

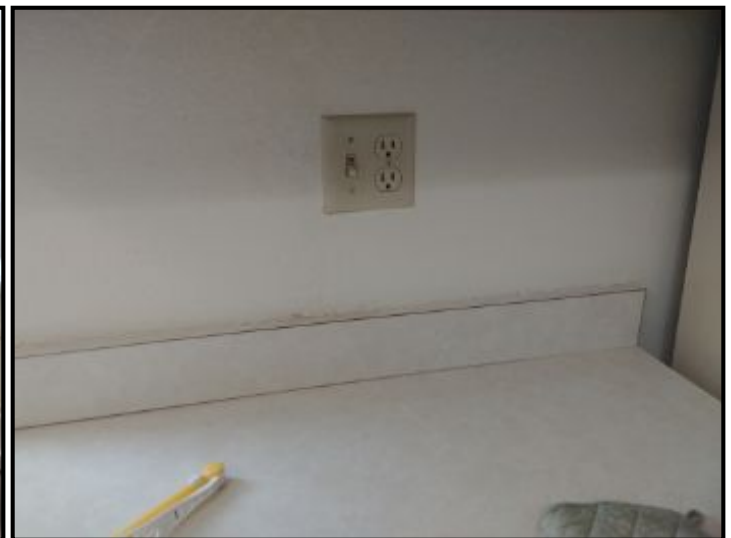
No GFCI at kitchen counter

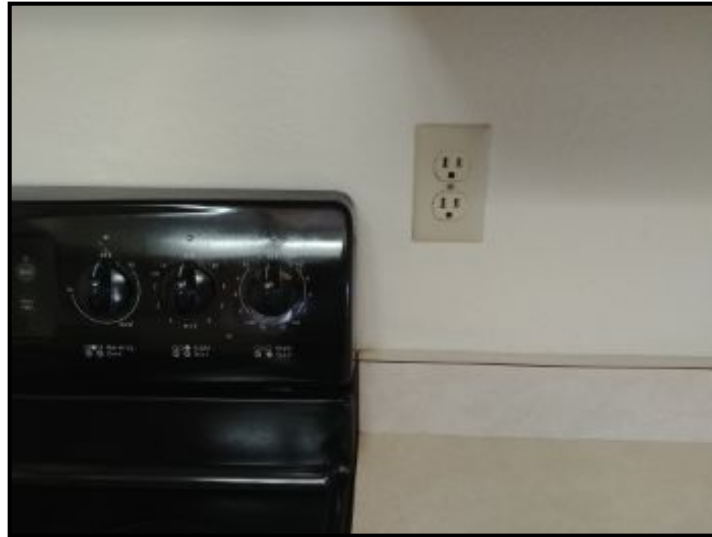
- No GFCI protection present, suggest installing GFCI protected receptacles for safety.

No GFCI in kitchen area

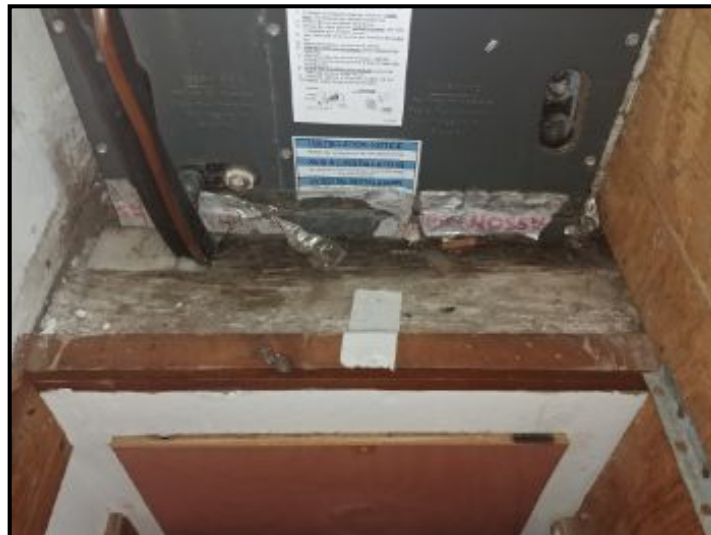
Signs of prior water at AC handler

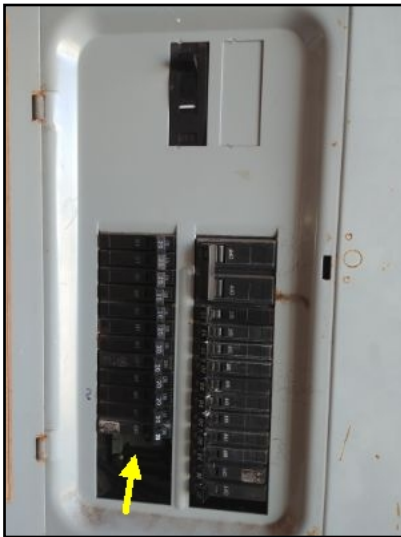
- GE panel
- Panel cover screw(s) too tight too loosen. Panel cover not removed
- Open breaker panel slot(s) at panel box cover. Electrocutation hazard.
- Bushings missing from around wire(s) entering panel box.
- Recommend having breaker connections evaluated by a licensed electrician.
- Panel box appears to be older than the projected effective life (25 years) of panel buss bar and breakers; recommend electrician evaluation of panel box and associated wiring, including non-tripping GFCIs on property.

Open Breaker spaces in panel

- Open breaker panel slot(s) at panel box cover. **Electrocution hazard.**
- We recommend contacting a licensed electrician to evaluate and repair the issues.

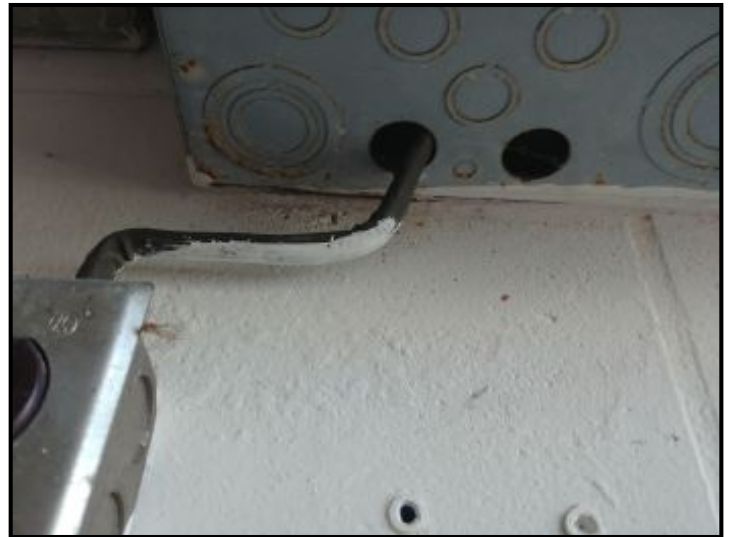
Missing bushings under panel

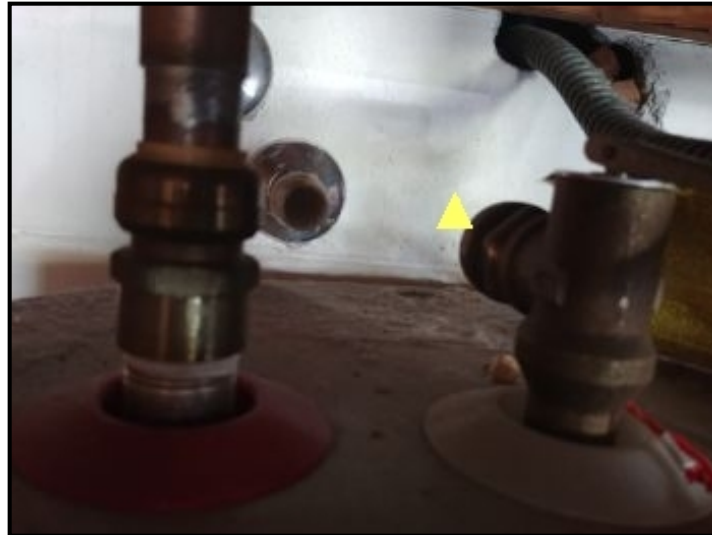
- There is no TPR valve present on this water heater. This is a serious safety concern and needs to be corrected at once. We recommend contacting a licensed plumber to install a proper valve.

Missing TPR valve

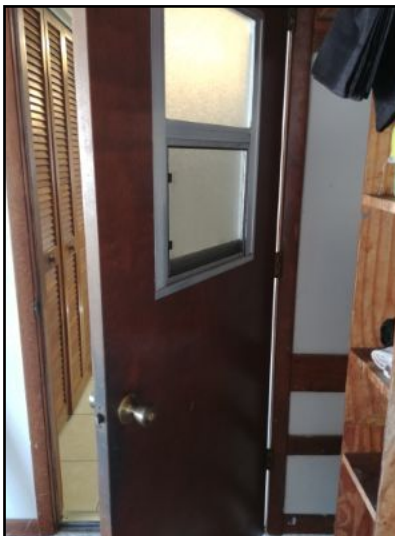
- The door between the garage & house is not a fire rated door. This may not have been required when originally built. Fire doors are fundamental to the integrity of fire barriers which provide resistance to the spread of fire, smoke, and toxic gasses. This means that should a fire occur in the garage, this door does not afford protection until fire-rescue people arrive. This door should be replaced with a fire rated door.
- There is no self-closing device on the door from the house leading to the garage. It is strongly recommended that one be installed in order to protect the residence against garage originated fires.

Hollow wood door at garage/kitchen

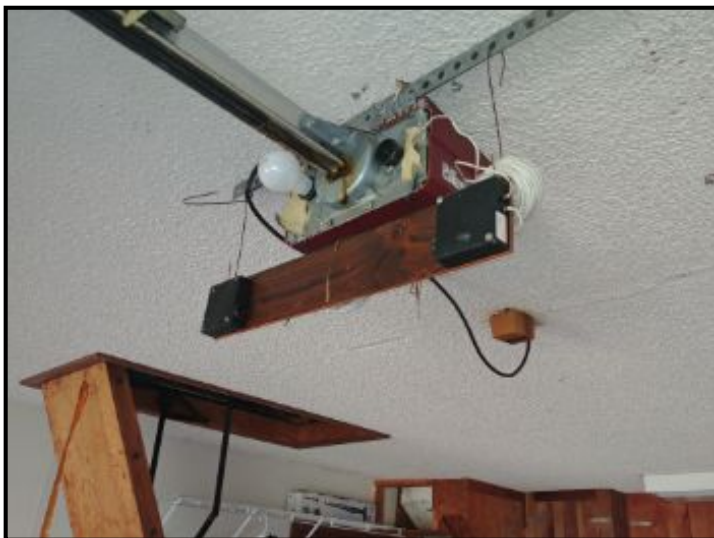
Missing cover

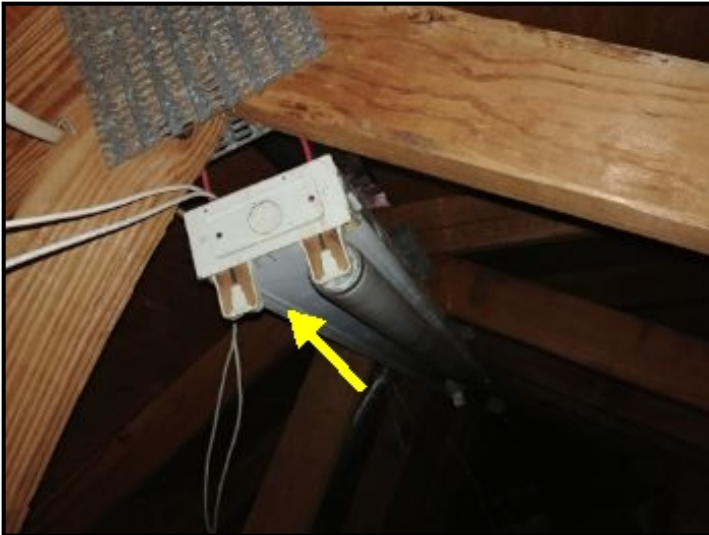
- Loose hanging light fixture observed, suggest repairing for safety.
- All wiring should be properly secured to the framing.

Missing bulb/ unsecure wiring

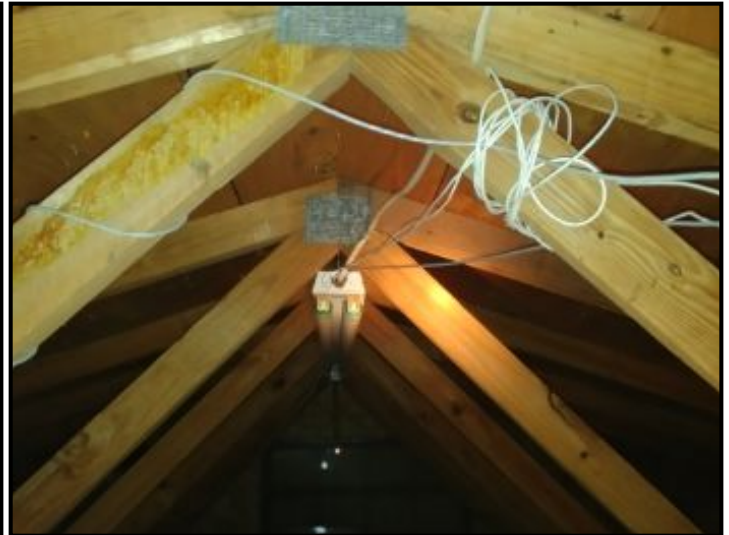
Unsecured wires

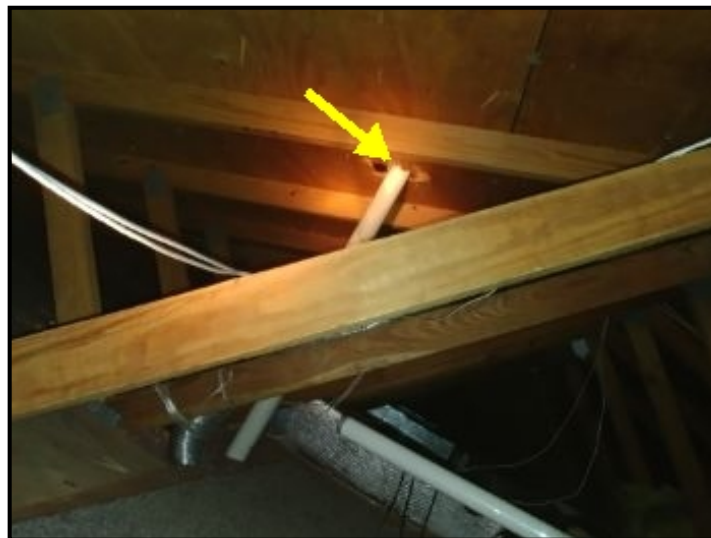
Large hole through roof pvc vent pipe
