**PROPERTY INSPECTION REPORT**

**Bill Kania #HI 11351**  
**GREATER ORLANDO HOME INSPECTIONS**

**Maderia Dr, Kissimmee FL 34758**  
**Inspection Prepared For: Vince**

**Date of Inspection: 12/8/18**  
**Year Built: 1985 Size: 1200 sq ft**  
**Weather: Sunny 85 degrees**

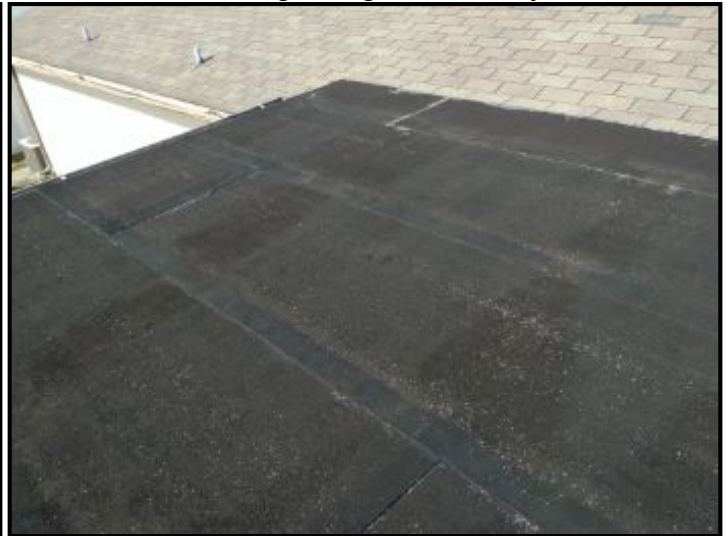
Roll roofing on rear patio

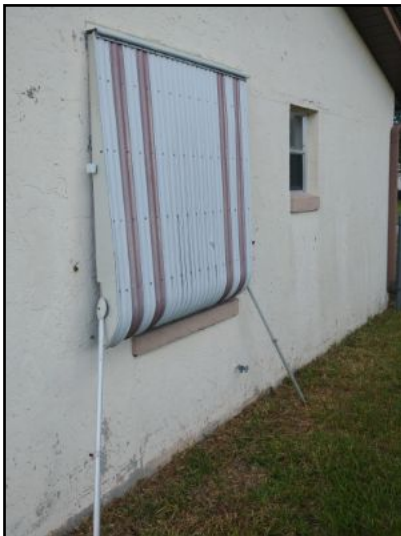
Unsecured awning- north

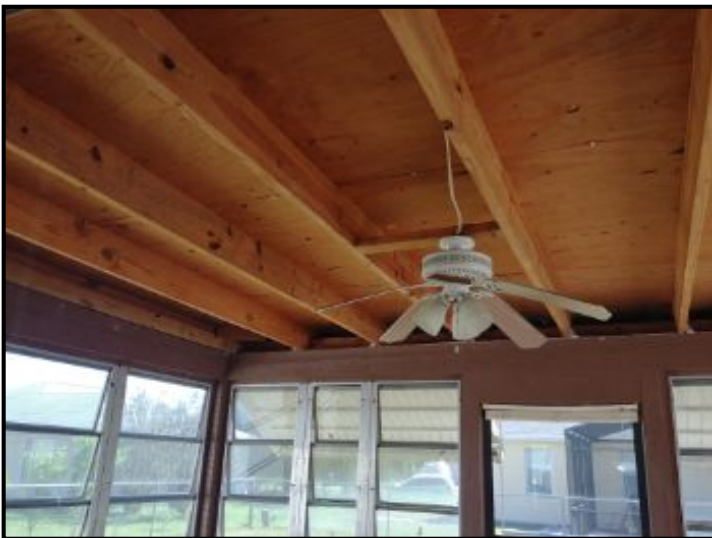
- Concrete floor in good condition. Some flaking of concrete in corner/paint peeling. Appears to be a result of water damage.
- Window crank not working
- Ceiling fan blades wobbly and sagging
- No mounting box for ceiling fan

Rear enclosure fan

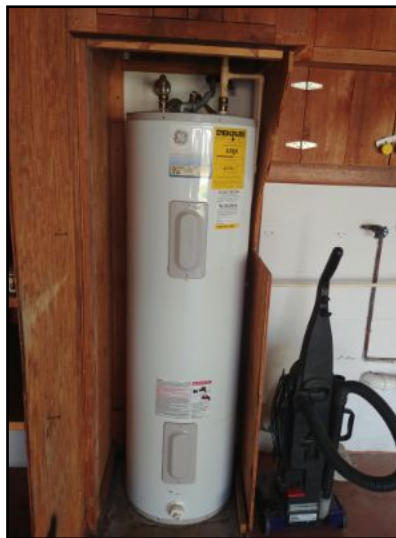
- A Temperature Pressure Relief (TPR) valve is not present. This safety valve releases water (and thus relieves pressure) if either the temp or pressure in the tank gets too high. The **TPR valve** discharge tube must be made of copper, iron, or CPVC (NOT regular PVC). It must terminate within 6" above the floor--the end cannot be threaded or have a fitting.

Water heater in garage

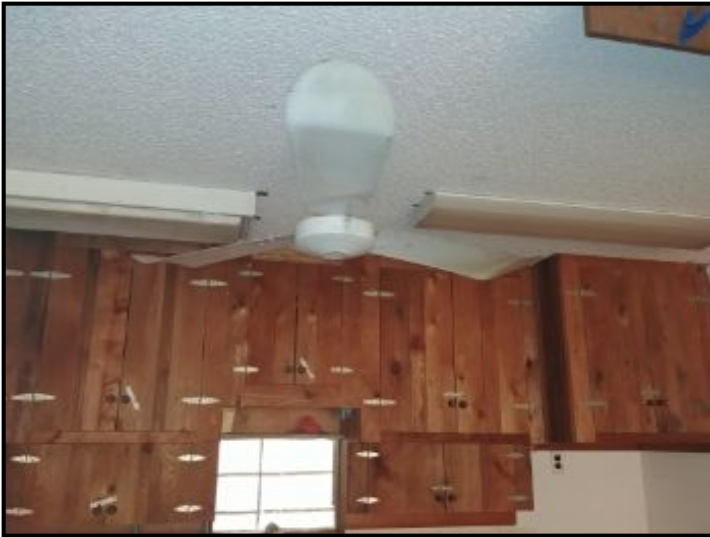
- Appeared functional and in satisfactory condition, at time of inspection.

Wood cabinets and fan

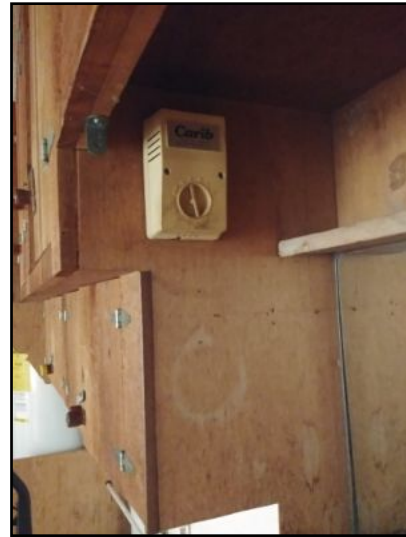
Fan control in garage

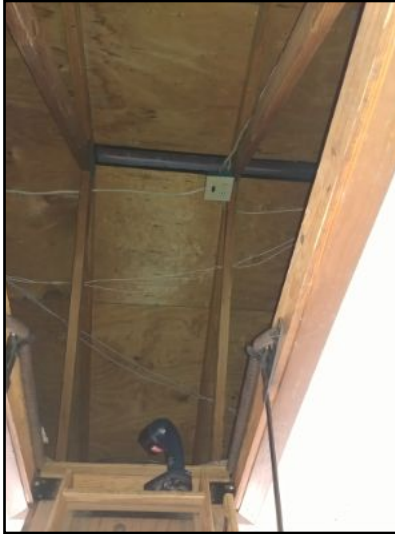
- Dimensional lumber wood ceiling joists.
- Plywood Sheathing noted.
- Wood Joists noted.
- Pull down ladder is not fire rated.

Pull down ladder in garage

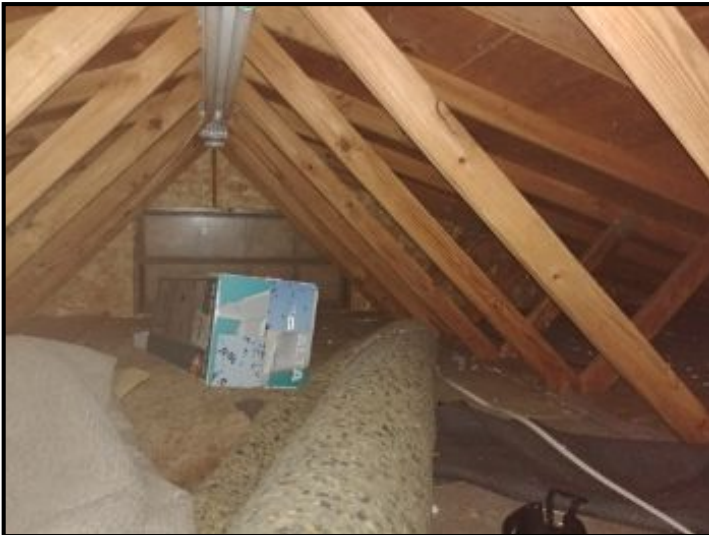
Rafters over garage area

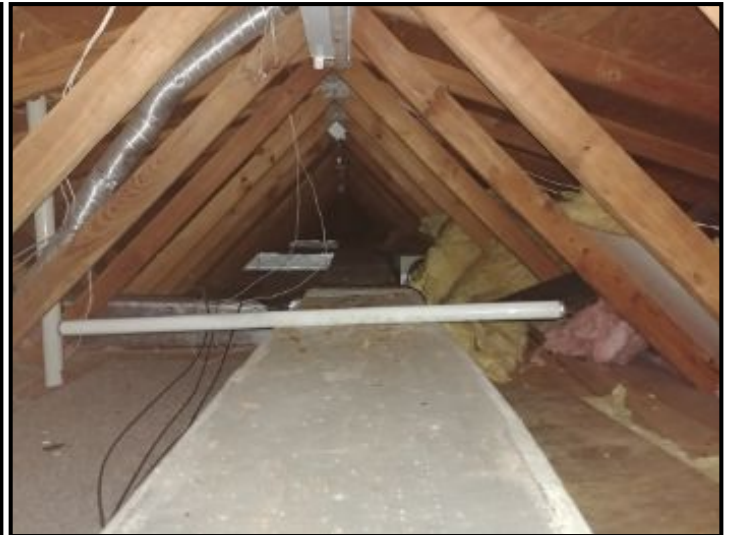
Attic rafters and venting

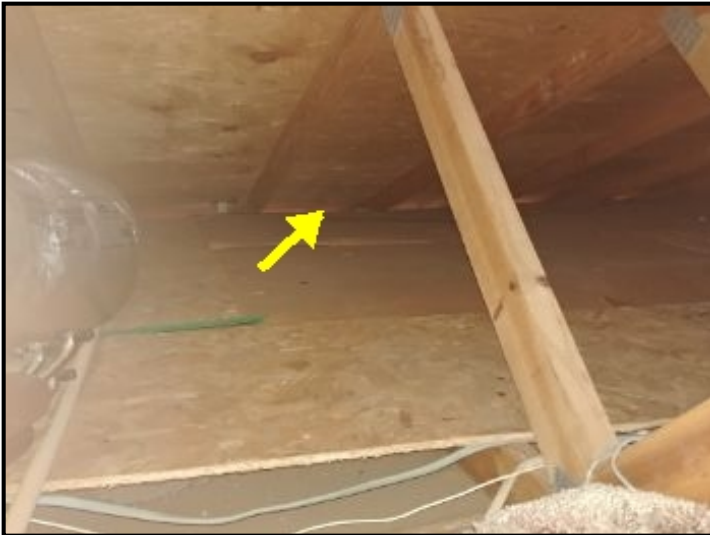
Attic space to soffit vents

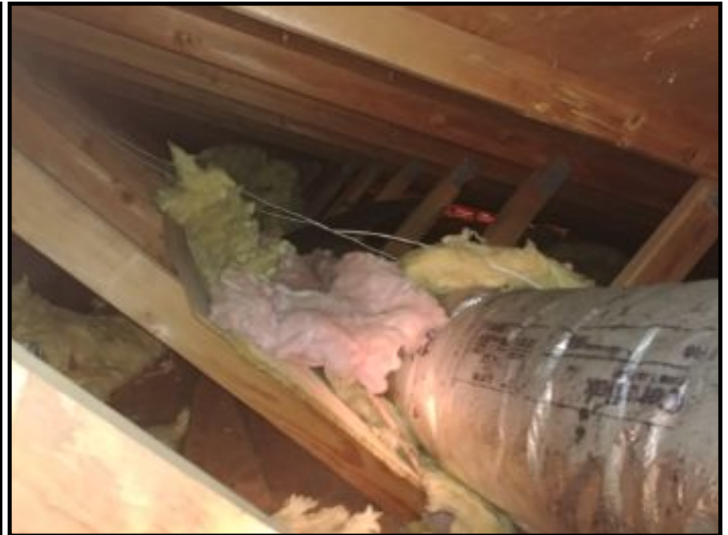
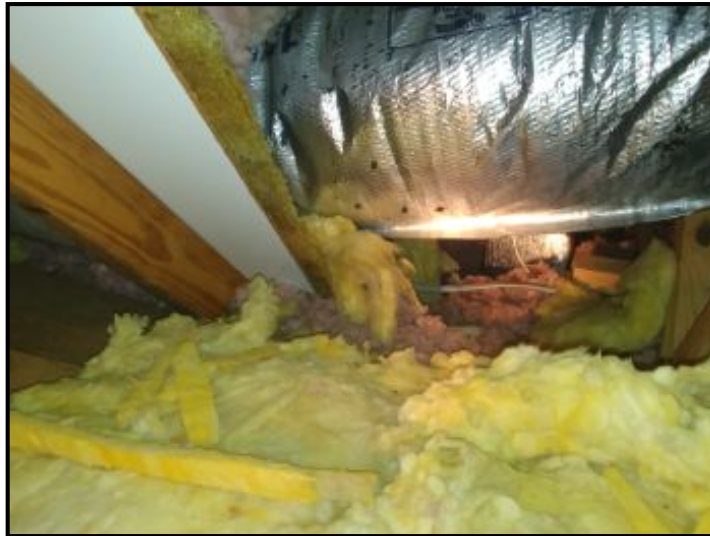
- Insulation level in the attic is typical for homes this age
- **Irregular insulation.**

Attic insulation/AC duct

Attic insulation and AC duct
