**PROPERTY INSPECTION REPORT**

**Bill Kania #HI 11351**  
**GREATER ORLANDO HOME INSPECTIONS**

**Maderia Dr, Kissimmee FL 34758**  
**Inspection Prepared For: Vince**

**Date of Inspection: 12/8/18**  
**Year Built: 1985 Size: 1200 sq ft**  
**Weather: Sunny 85 degrees**

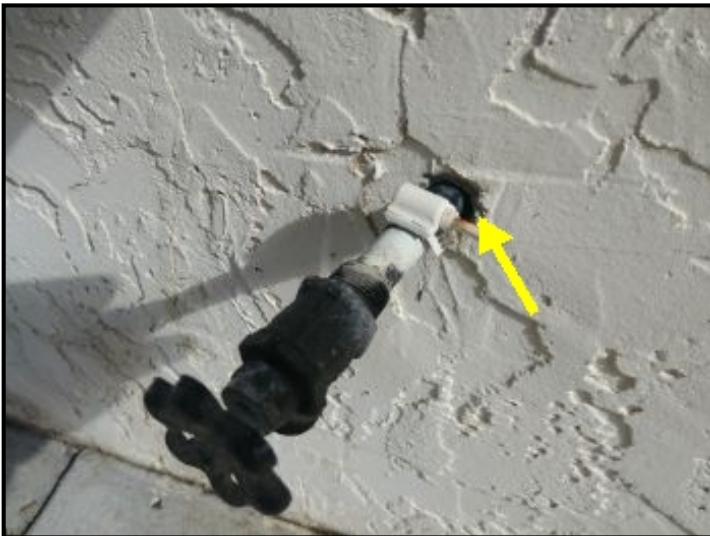
Pipe not sealed into house

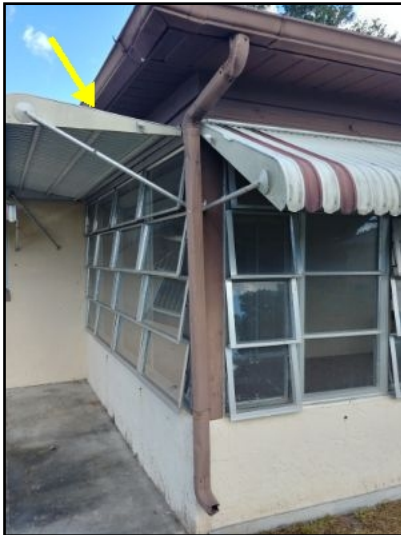
Awning pitches back toward the windows

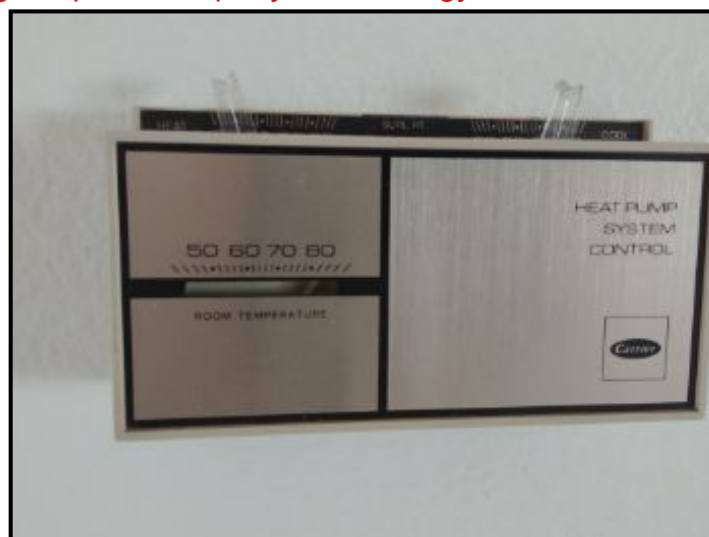
- Analog, non-programmable type.
- Functional at the time of inspection.
- Thermostats are not checked for calibration or timed functions.
- **IMPROVE:** Non-programmable thermostats have no energy saving capabilities as do digital setback-type thermostats. Recommend an upgrade to a modern, digital programmable thermostat. This could yield a saving of up to \$180 per year in energy costs.

Thermostat LR

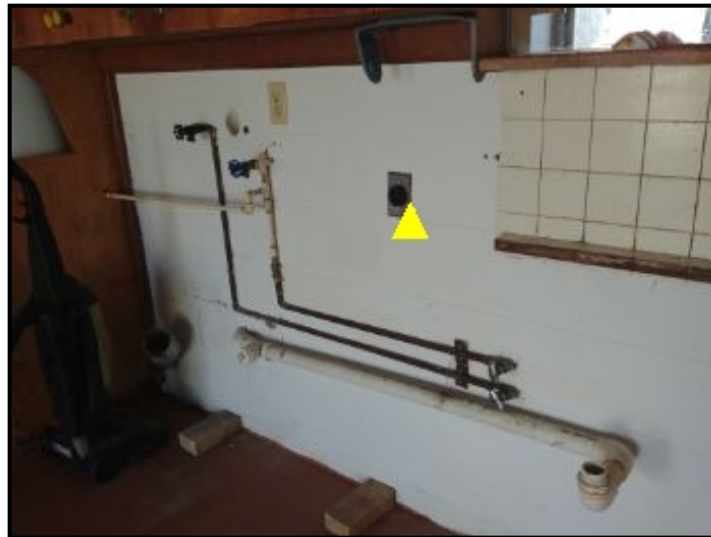
- The 240 volt outlets tested functional.

Laundry/sink connections and basin sink drain w/ 240 outlet

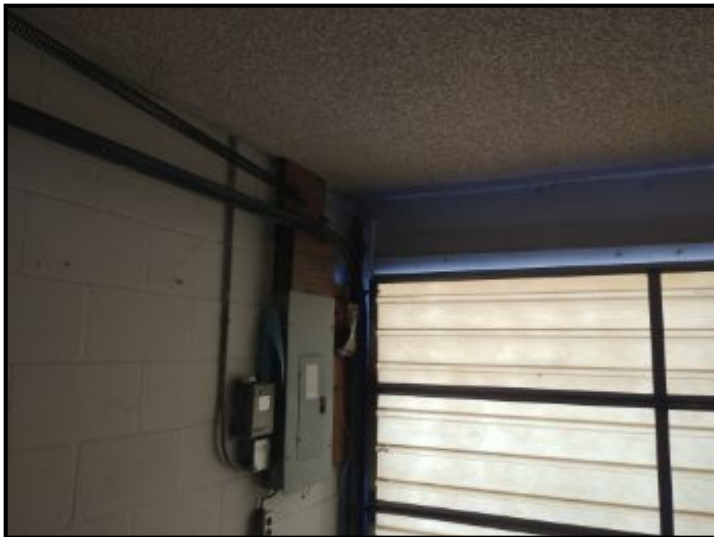
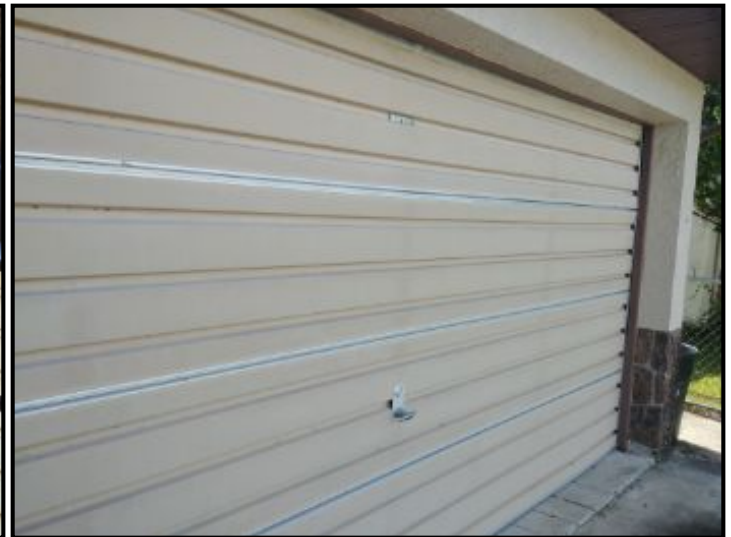
- Four- 16 ft fiber glass panel garage door • Sectional door noted.
- DEFFERED COST: Upgrade to newer metal insulated door. • Weathered
  - Functioned when operated although noisy. Recommend evaluation by garage door contractor

Fiberglass garage door

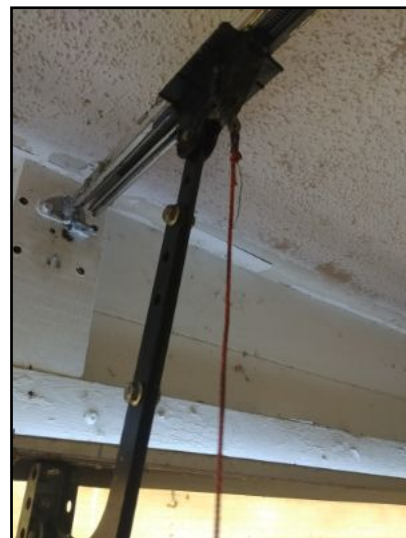
Garage door release
